Manhole Inspection Summary

Manhole # S07II2007MH

Location Address: **6333 WILLOW GLEN DR** Cross Street: **OLD PIMILIOC RD**

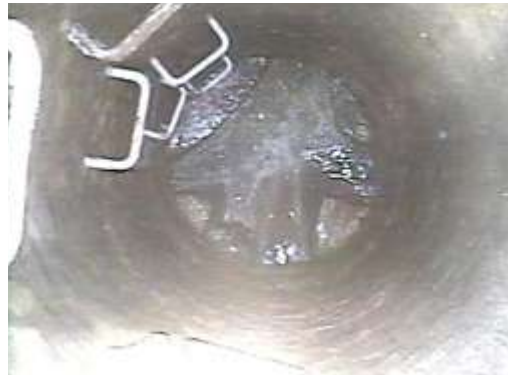
Top View

Chimney / Frame Adjustment ☒ Exists Material: **Brick** ☐ Parged Height: **1** (in.)
Condition: ☐ Sound ☐ Cracked ☐ Root Intrusion ☒ **Loose Brick** ☒ **Deteriorated**
Infiltration: ☐ None ☒ **Joint** ☐ Cracks ☐ Mortar ☐ Roots ☐ Wall

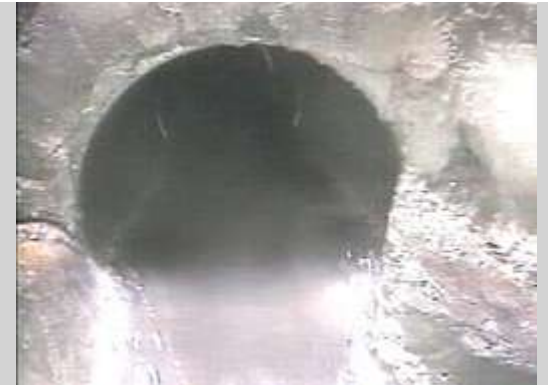
15 in. Circular Gravity Sewer

Pipe Material: **Clay** ☐ Pipe Lined

Infiltration: **None** Pipe Seal Cond: **Unknown**
